**Confidential Inspection Report**  
**567 Washington St**  
**Monroe Township, NJ 08053**

**Prepared for: Mr & Mrs John Smith**

**Prepared by: Victory Home Inspections LLC**  
**786 Garwood Rd**  
**Moorestown, Nj 08057**  
**856-235-0564 [victoryhi@comcast.net](mailto:victoryhi@comcast.net)**

February 12, 2010

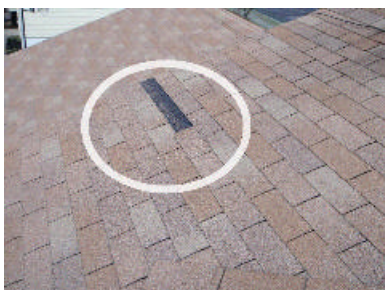
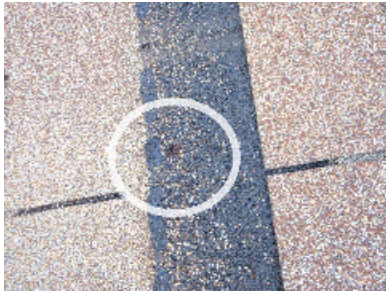
##### *3.5 Condition of Roof Covering Material:*

**The roof covering material shows evidence of deterioration or leakage to the degree that action is required to determine the extent of repairs needed.** Estimates from licensed professionals are needed. The nails are rusting through to the point that the shingles are loose and coming off. The area of concern is below the chimney.

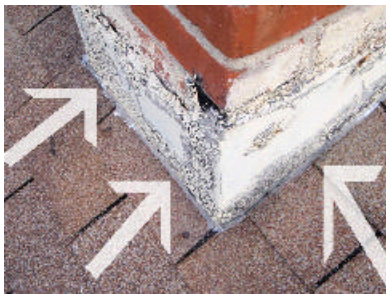
**3.9 Flashing:**

Some portion of the roof flashing needs immediate repair. Have a licensed roofer give an estimate for repairs. The step flashing around the chimney is deteriorated or damaged. Repairs or replacement is needed to prevent water from leaking in.

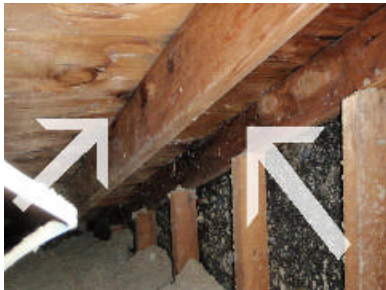
**3.19 Evidence of Leaks on Interior of Attic:**

**There is evidence of a current leak noted on the underside of the roof decking or rafters.** From the chimney area.

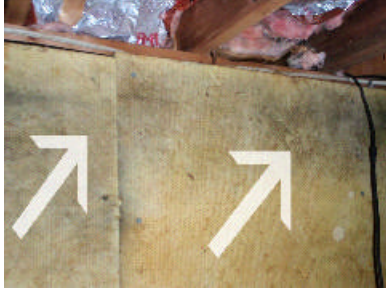
**4.19 Evidence of possible mold noted:**

Yes. There appears to be possible mold or fungus noted on the insulation on the foundation walls. Further testing is recommended and needed to determine the type. Testing for airborne mold is an option that Victory Home Inspections LLC can conduct.

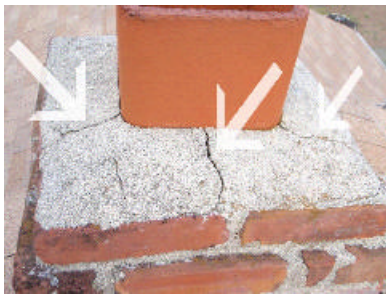
**4.24 Chimney Cap or Crown:**

The chimney cap is made of mortar. Its function is to keep water from entering the masonry stack, causing deterioration. This cap needs some repair so that it can function as intended. The cap is cracked. Seal the cracks with outdoor caulking to.

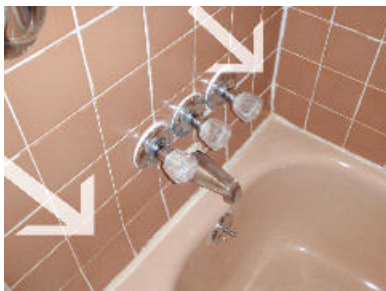
**5.8 Tub & Shower Walls:**

**There is deterioration to the walls that calls for immediate action.** There are loose tiles. I recommend removing the loose tiles to expose any possible damage and make repairs if necessary. The inspector is not responsible for any hidden damage. The extent of the damage is undetermined. Invasive inspection is recommended. Services of a professional licensed contractor are needed to make necessary repairs.

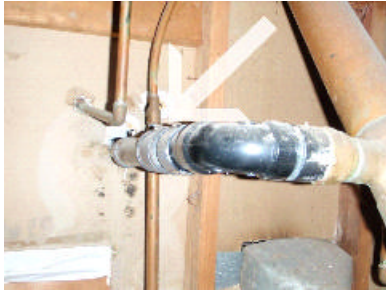
#### *9.15 Supply/Waste Piping Supports:*

Of the existing support straps and hangers, at least one loose or broken support exists and needs to be repaired or replaced. Sagging was noted in the waste piping. This will eventually lead to clogging of the pipe. Eliminating the sag to prevent blockage is recommended. The waste pipe from the kitchen sink in the crawlspace.

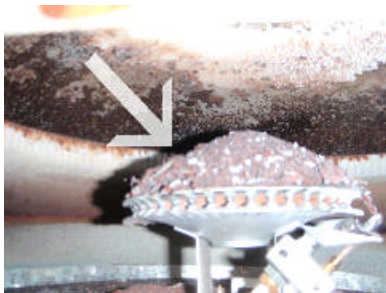
#### *9.23 Firebox Condition*

There is rust on the underside of the tank.

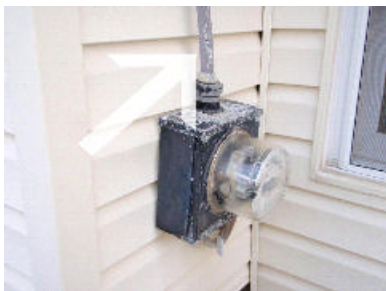
#### *10.2 Service/Entrance/Meter:*

There is some portion of the masthead, support, meter housing, or cable entrance to the structure that **REQUIRES THE IMMEDIATE ATTENTION** of a qualified licensed electrician. The cable is deteriorated and needs to be replaced. Contact a licensed electrician for repairs.

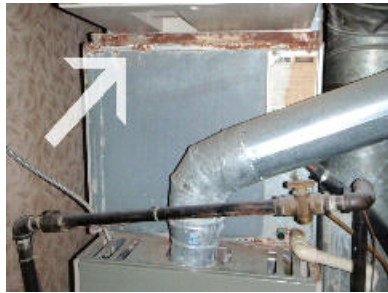
*11.20 Condition*

There is rust noted on the heating system. The humidifier appears to be leaking into the system.

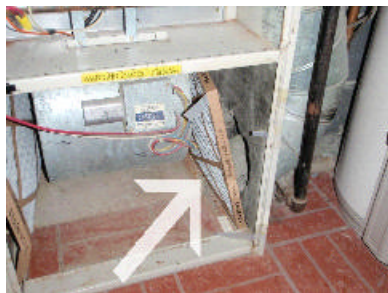
*11.29 Filter Condition:*

Replacement is recommended; the filter is not functioning as intended. The filter is not correctly installed. For proper functioning, all air must pass through the filter. This filter needs to be adjusted or secured.

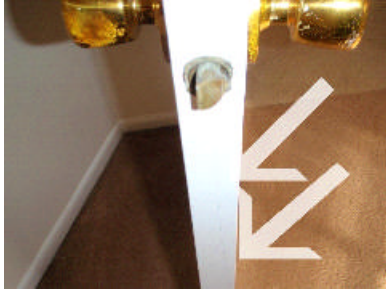
*13.1 Master bedroom*

Damage viewed, Door hardware needs some adjustment or repair for it to function appropriately. The door skin is punctured or broken. It is no longer performing as intended.

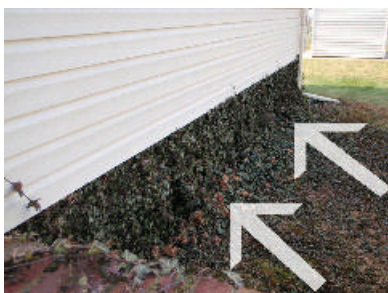
- 2.1 Bushes and Shrubs Condition:** Bushes and shrubs need to be trimmed away from the structure at least 2 inches. This space is needed to prevent direct access to the structure by insects and to keep the bushes from damaging the siding.

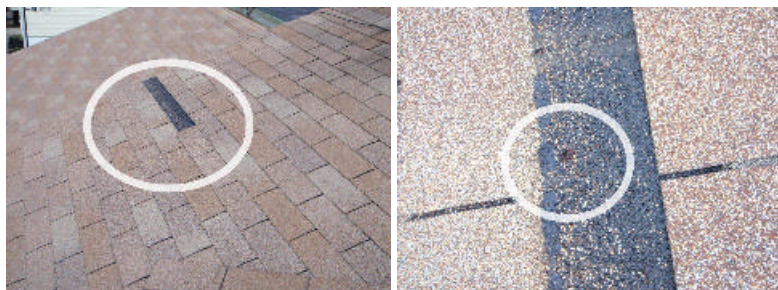
3.4 Underlayment Noted:	Asphalt impregnated felt underlayment was noted under the roofing material in at least 2 locations that were checked.
3.5 Condition of Roof Covering Material:	<b>The roof covering material shows evidence of deterioration or leakage to the degree that action is required to determine the extent of repairs needed.</b> Estimates from licensed professionals are needed. The nails are rusting through to the point that the shingles are loose and coming off. The area of concern is below the chimney.

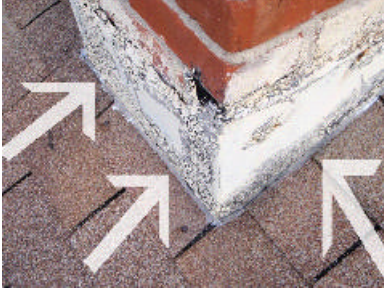
3.6 Condition of sub-roof from above	The sub-roof appear to be in satisfactory condition.
3.7 Estimated Life Expectancy of Roof:	The roof covering material appears to have a remaining life expectancy of up to 5 years, assuming proper maintenance is completed as needed. The life expectancy given is the best estimate of the inspector, assuming proper maintenance. The actual life of the roofing materials used can be influenced by external sources like weather extremes, conditions caused by trees and vegetation, and mechanical damage.
3.8 Slope:	Medium slope is considered to be between 4 in 12 and 6 in 12.
3.9 Flashing:	Some portion of the roof flashing needs immediate repair. Have a licensed roofer give an estimate for repairs. The step flashing around the chimney is deteriorated or damaged. Repairs or replacement is needed to prevent water from leaking in.

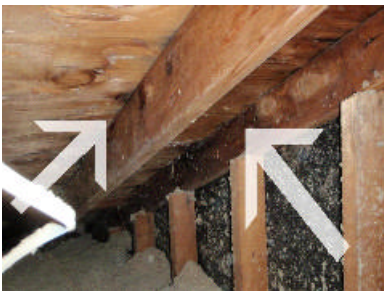
Bedroom closet wall. Hallway ceiling.  
 Ceiling scuttle hole.  
 The attic cavity was inspected by entering the area.  
 Crawl Through - The attic cavity is not useable for any storage due to size, framing, or insulation.  
 A rafter system is installed in the attic cavity to support the roof decking. The rafters or truss system appears to be in satisfactory condition.  
 The roof decking material is 1/2" plywood sheeting.  
**There is evidence of a current leak noted on the underside of the roof decking or rafters.** From the chimney area.

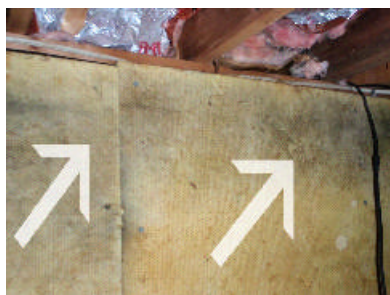
- 4.19 Evidence of possible mold noted: Yes. There appears to be possible mold or fungus noted on the insulation on the foundation walls. Further testing is recommended and needed to determine the type. Testing for airborne mold is an option that Victory Home Inspections LLC can conduct.

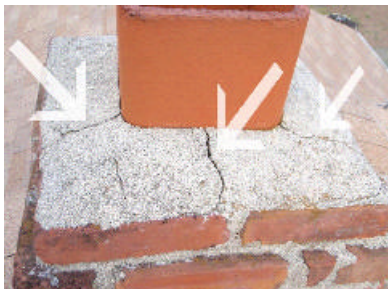
- 4.24 Chimney Cap or Crown: The chimney cap is made of mortar. Its function is to keep water from entering the masonry stack, causing deterioration. This cap needs some repair so that it can function as intended. The cap is cracked. Seal the cracks with outdoor caulking to.

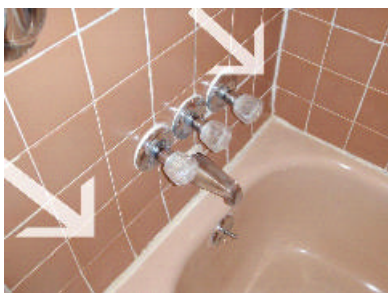
**There is deterioration to the walls that calls for immediate action.** There are loose tiles. I recommend removing the loose tiles to expose any possible damage and make repairs if necessary. The inspector is not responsible for any hidden damage. The extent of the damage is undetermined. Invasive inspection is recommended. Services of a professional licensed contractor are needed to make necessary repairs.

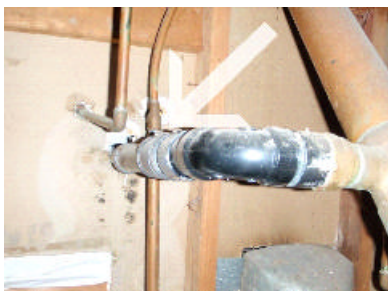
- 9.15 *Supply/Waste Piping Supports:* Of the existing support straps and hangers, at least one loose or broken support exists and needs to be repaired or replaced. Sagging was noted in the waste piping. This will eventually lead to clogging of the pipe. Eliminating the sag to prevent blockage is recommended. The waste pipe from the kitchen sink in the crawlspace.

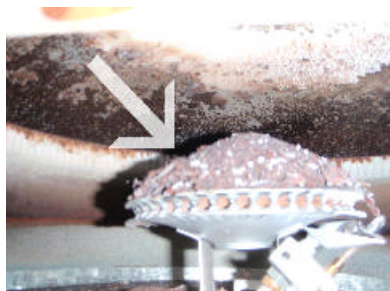
- 9.18 *Location:* Utility Room:
- 9.19 *Age* The water heater is 14 years old. The water heater appeared to be past its design life and may need replacement soon.
- 9.20 *Tank Capacity:* A 40 gallon water heater is installed.
- 9.21 *Fuel Source for Water Heater:* The water heater is gas-fired.
- 9.22 *Exposed Water Heater Condition:* It shows some age, but it appears sound.
- 9.23 *Firebox Condition* There is rust on the underside of the tank.

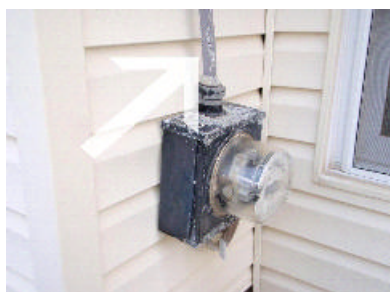
- 10.1 Service Voltage:** The incoming electrical service to this structure is 120/240 volts.
- 10.2 Service/Entrance/Meter:** There is some portion of the masthead, support, meter housing, or cable entrance to the structure that **REQUIRES THE IMMEDIATE ATTENTION** of a qualified licensed electrician. The cable is deteriorated and needs to be replaced. Contact a licensed electrician for repairs.

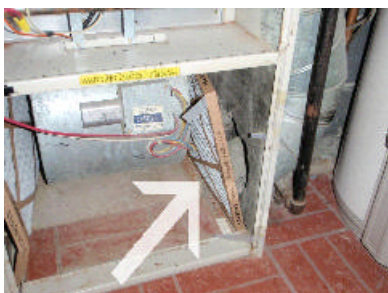
**11.29 Filter Condition:** Replacement is recommended; the filter is not functioning as intended. The filter is not correctly installed. For proper functioning, all air must pass through the filter. This filter needs to be adjusted or secured.

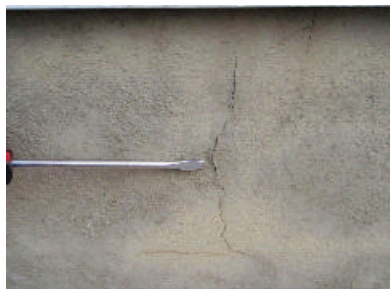
- 12.4 Visible Foundation Wall Cracks Noted From Exterior:** Shrinkage cracks are hairline cracks that are caused by the evaporation of water in the mix. This is a normal condition. Seventy-five percent of all shrinkage cracks appear in the first year.

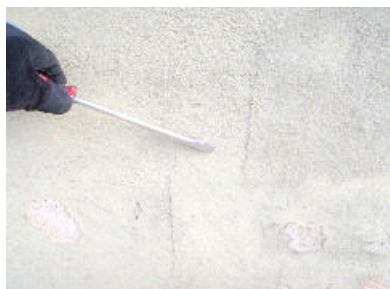
- 12.5 Location of Wall Cracks and Description:** Vertical cracks were noted in at least one exterior wall. Rear wall by the patio.

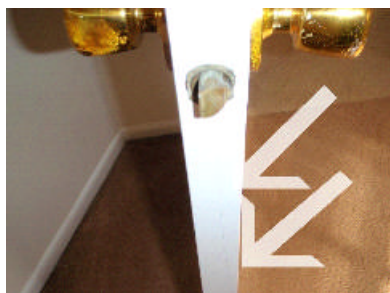
Damage viewed, Door hardware needs some adjustment or repair for it to function appropriately. The door skin is punctured or broken. It is no longer performing as intended.
