**Confidential Inspection Report**  
**567 Washington St**  
**Monroe Township, NJ 08053**

**Prepared for: Mr & Mrs John Smith**

**Prepared by: Victory Home Inspections LLC**  
**786 Garwood Rd**  
**Moorestown, Nj 08057**  
**856-235-0564 [victoryhi@comcast.net](mailto:victoryhi@comcast.net)**

February 12, 2010

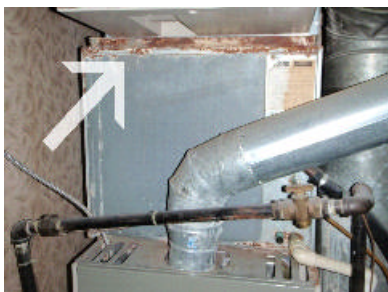
*11.20 Condition*

There is rust noted on the heating system. The humidifier appears to be leaking into the system.

- 11.19 Unit Tested: Yes.
- 11.20 Condition: There is rust noted on the heating system. The humidifier appears to be leaking into the

system.
